Hot In-Place Recycled Asphalt Pavement

Interim Report

Experimental Feature X(04)03 – New Products

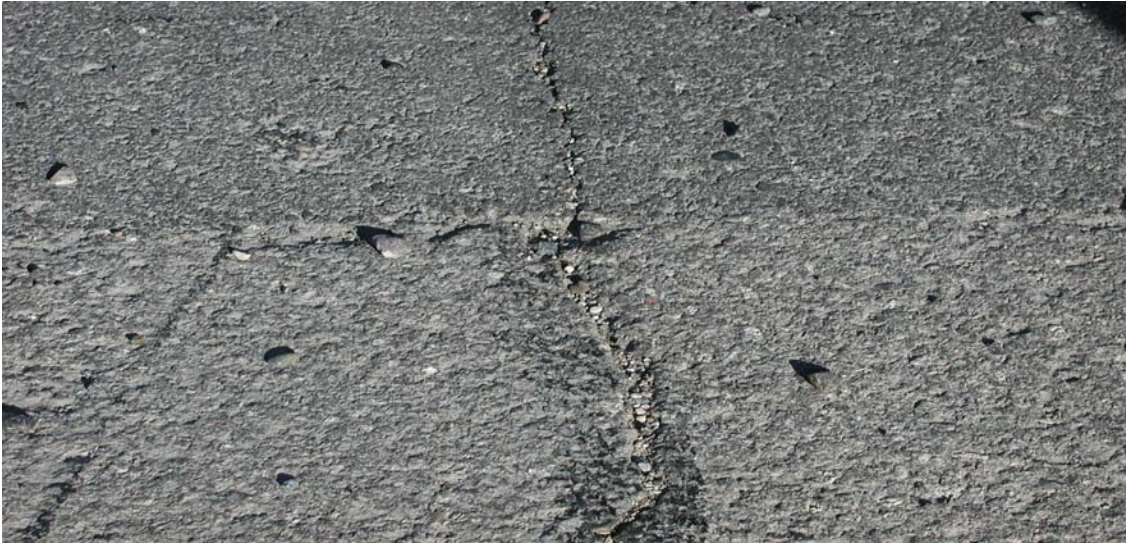
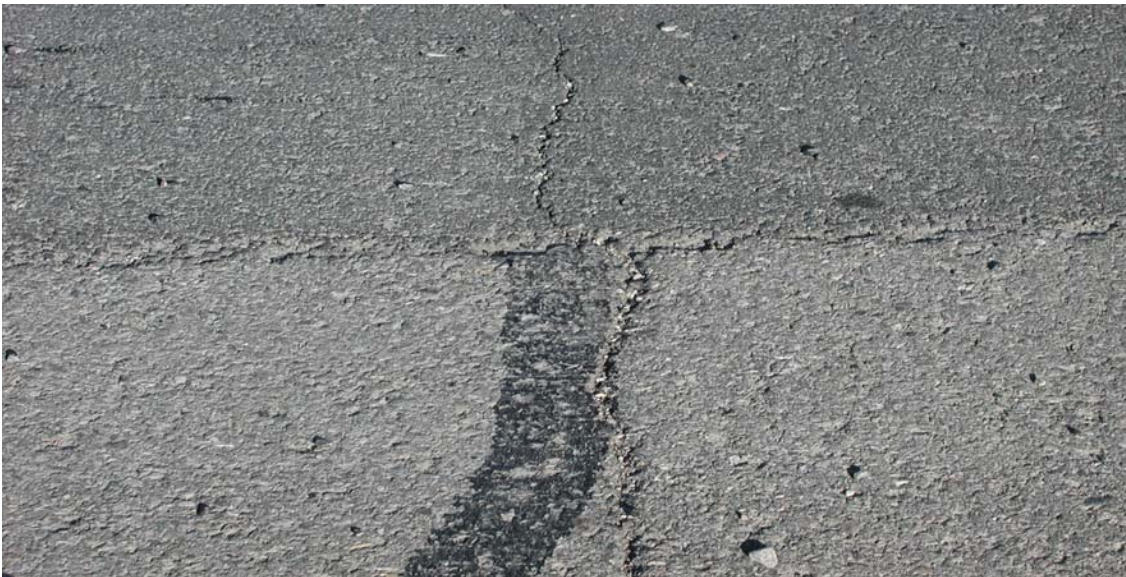
A visual evaluation was performed in May 2005 on US 89 and the old cracks that were to be eliminated had already radiated through the 2" of heater recycle in just eight months. In June 2005, the Fish Lake Project was visited to see if the same thing had occurred. Again, extensive cracking was evident.

At this time and based upon the visual inspection in 2005, it is apparent that the recycling did not slow down the old surface appearance for very long as the cracks in the new pavement were reflecting through and matching the old surface appearance.

The following photos show the difference between the old pavement and the recycled material. Note that the light gray is the old pavement and the dark is the recycled material at eight months.

The process had cracks reflect up through 2" of repave in eight months and this is not the time frame that was hoped for. The chip seal applied in the next season is something that should be evaluated for a few years to see if there is any early failure that may be caused by the heater repave process.
